Fernhurst Furnace Preservation Group

The 2022 Repair Project in Pictures – Before and After Repair

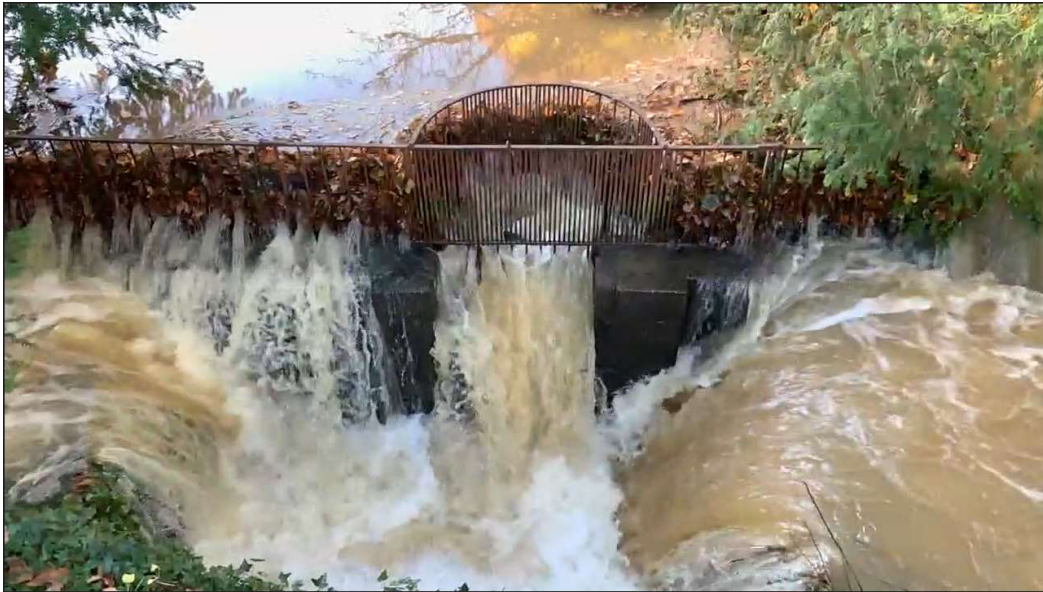
Over time both these sluices have gradually failed to function correctly, allowing flood water during heavy rain to pour over and around the northern sluice and then over the archaeological remains of the furnace causing severe damage.

↑ Flood water overflowing and around the northern sluice which feeds the furnace workings.

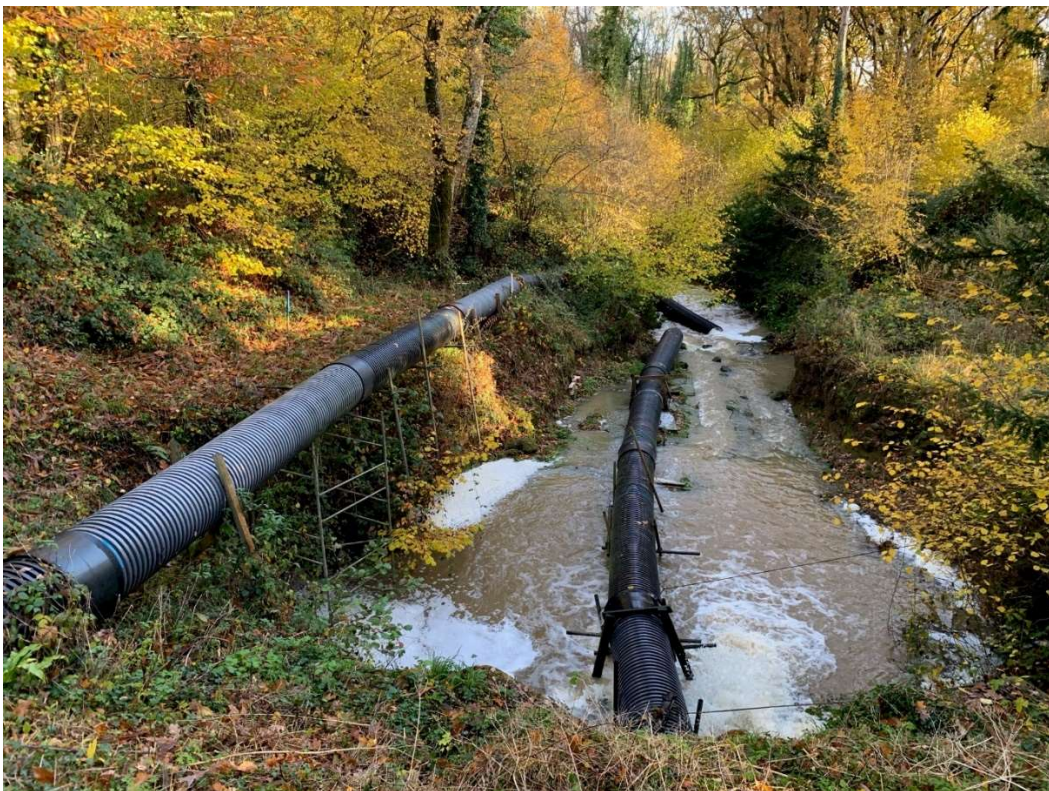
↑ Floodwater damaging the archaeological remains of the furnace site.
The black tubing is a temporary addition to help divert floodwater over the site.

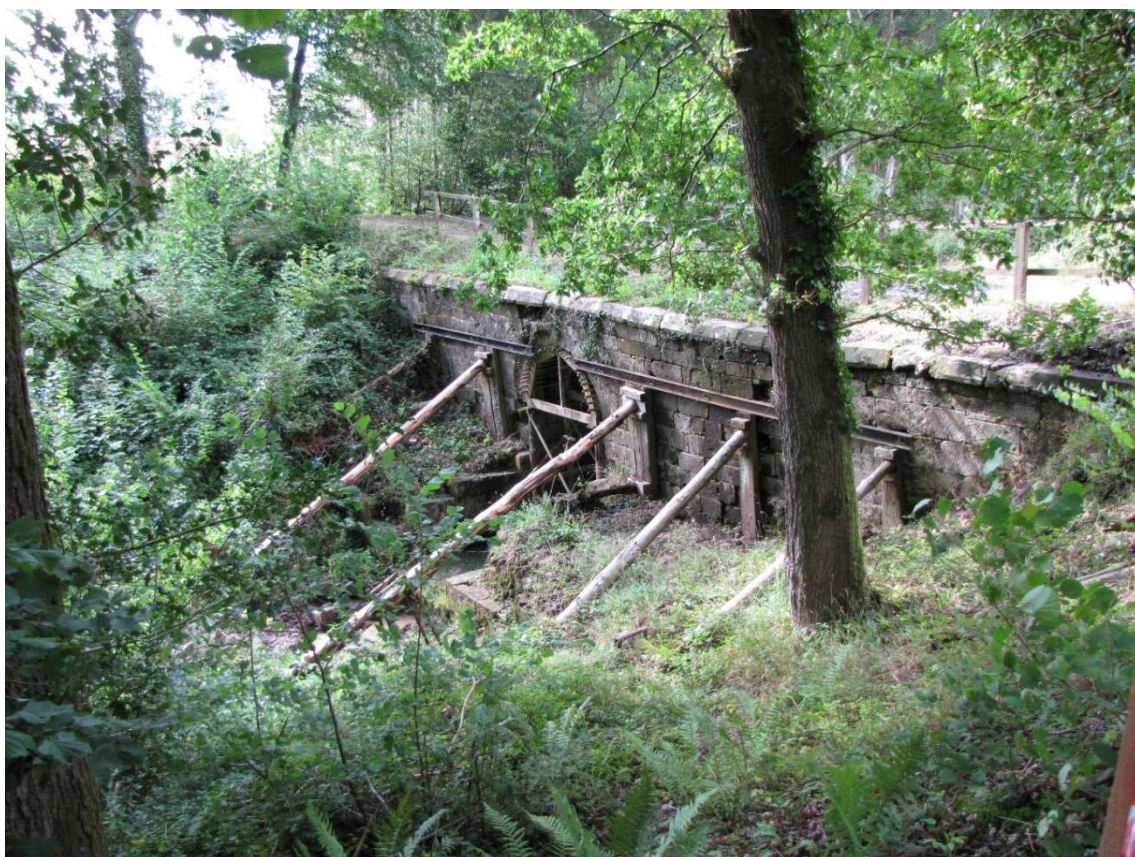
The southern sluice was leaning outwards and in danger of collapse and was only discharging a little of the excess water from the pond.

↑ Before repair – The sluice in the dam wall leaning outwards and in danger of collapse
